## Właściwości materiałów budowlanych zastosowanych w historycznej konstrukcji murowanej meczetu Hacı Hasan Feyzi

## Properties of the bearing construction materials used in a historical masonry structure of Hacı Hasan Feyzi mosque

**Solak Adem<sup>1</sup>**

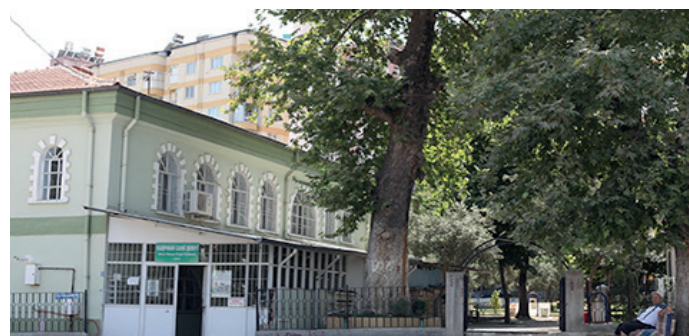
Rys. 1. Widok meczetu Hacı Hasan Feyzi przed usunięciem tynku

Fig. 1. View of Hacı Hasan Feyzi Mosque before scraping

Historical Hacı Hasan Feyzi Mosque structure, which was registered as an immovable cultural asset on 07.12.1980, is located in the Kuşpınar neighborhood of Pamukkale district, which is the central district of Denizli. The building is an Ottoman Period historical building built in 1884 [Fig. 1].

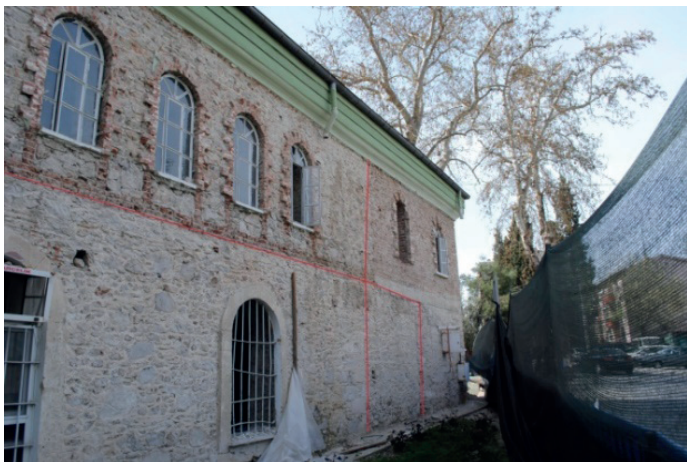
Rys. 3. Różnice w fakturze i dylatacjach ścian wschodnich budynku

Fig. 3. Building eastern wall texture differences and dilatations

It is understood that lower part of the outer horizontal brick of the south, east and west sides of the building, belongs to the first building phase in 1884 - Figs. 3 and 4. On the other hand, the brick and second floor concrete beam materials of the northern ends of the eastern and western walls, shows that these parts may have been built later, between 1950-1970.

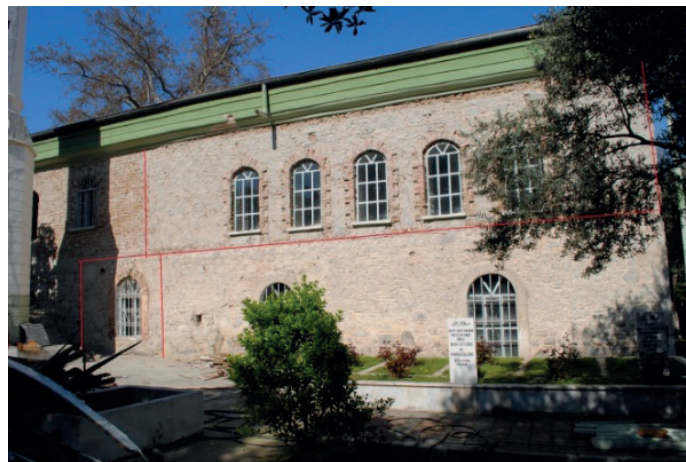
Rys. 4. Różnice w fakturze i dylatacjach ściany zachodniej budynku

Fig. 4. Building western wall texture differences and dilatations

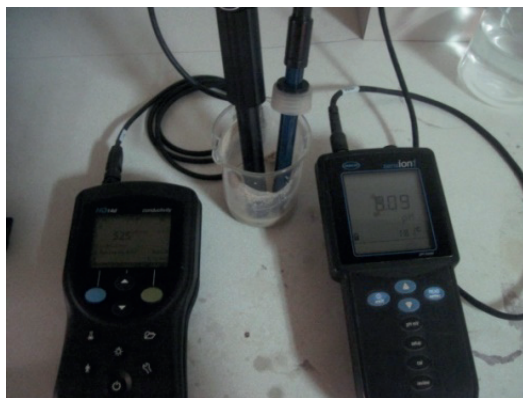
Rys. 5. pH-metr i cyfrowy zestaw do pomiaru przewodnictwa

Fig. 5. pH meter and digital conductivity measurement set

By examining the pH values, it was determined whether the mortars had weak base properties. The amount of water-soluble salts contained in the mortar samples and the salinity degree of the mortars were found, by electrical conductivity measurement (13,14). For the determination of total salt measurement in samples; 10 grams of sample taken in 50 ml of water was centrifuged for 1 hour and filtered, and standard sodium hexametaphosphate was added to it. The total salt contents of the samples prepared for analysis were recorded with the HACH SensION 1 pH conductivity meter and digital conductivity measurement set (Fig. 5), the results were obtained as a percentage by weight, using the relevant equations (15,16,17).

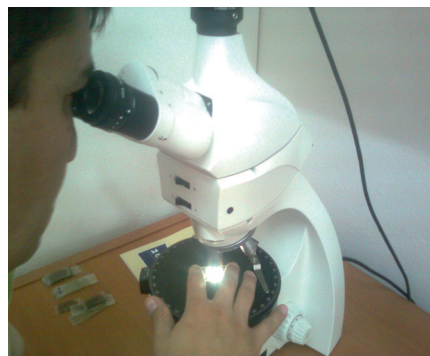
Rys. 6. Mikroskop stosowany w analizie cienkich próbek

Fig. 6. Polarized microscope used in thin section analysis

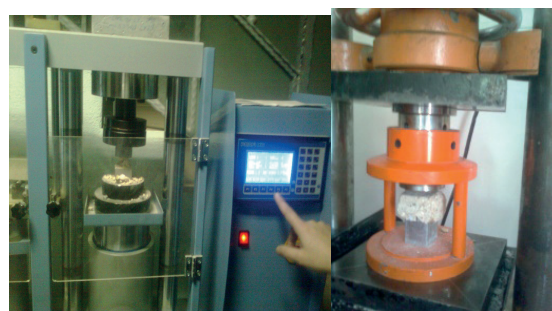
Rys. 7. Prasa hydrauliczna użyta do badania próbek zapraw

Fig. 7. Hydraulic press used for mortar samples testing

W celu określenia właściwości mechanicznych badanych materiałów oryginalnych z kamienia i zaprawy zbadano wytrzymałość pod obciążeniem jednoosiowym, za pomocą prasy hydraulicznej marki Tonitechnic, przedstawionej na rys. 7 i 8. Określono wytrzymałość na ściskanie [ $\sigma$ ] próbek z kamienia i zaprawy (30, 31).

In order to determine the mechanical properties of the examined stone and mortar original materials, the uniaxial loading test was performed with the Tonitechnic brand mechanical test device, given in Figs 7 and 8. At the end of the test, the compressive strength [ $\sigma$ ] of the stone and mortar samples was determined (30,31).

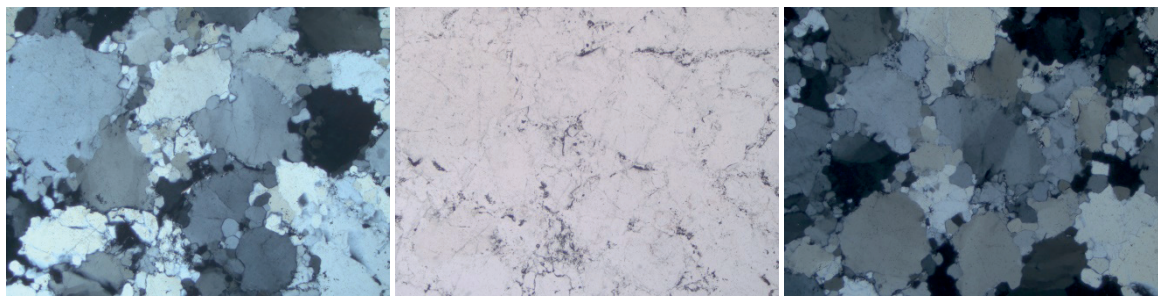
Rys. 10. Zdjęcia mikroskopowe analizy petrograficznej kamieni z próbki HHFTS3

Fig. 10. Petrographic analysis images of the HHFTS3 stone sample

In the thin section petrographic analysis of the stone samples of Hacı Hasan Feyzi Mosque Prayer Place and Tomb it has been clearly observed that it is quartzite, which is a metamorphic rock, composed mainly of quartz [close to 95%]. The boundaries of the quartz grains are intertwined. Moreover, it has been determined that the quartz grains have granoblastic texture. As an example, petrographic analysis images of the HHFTS3 stone sample are given in Fig. 10.

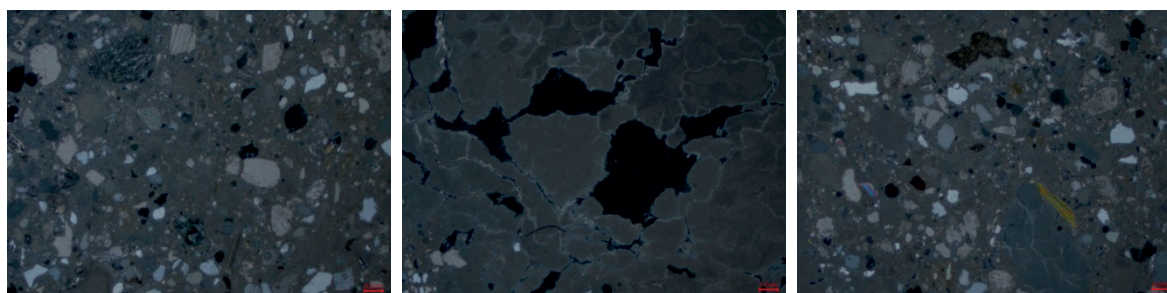
Rys. 12. Analiza petrograficzna zaprawy HHFTM3

Fig. 12. Petrographic analysis images of the HHFTM3 mortar sample

W analizie petrograficznej preparatów próbek zapraw HHFTM3 i HHFTM4 z grobowca meczetu Hacı Hasan Feyzi stwierdzono, że składa się ona z fragmentów skał metamorficznych, zawierających kwarcyt, marmur i łupki mikowe. Ponadto rozmiary ziaren są mniejsze niż w przypadku miejsca modlitwy. Jako minerały oznaczono ziarna kwarcu, zaokrąglone ziarna kalcytu oraz minerały: biotyty i muskowit, albit i nieliczne fragmenty dolomitu. Jako spoiwo jednoznacznie zidentyfikowano aglomeraty wapienne. Podobnie jak w miejscu modlitwy, pomimo, że połączenia kruszywa ze spoiwem

In thin section petrographic analysis of mortar samples HHFTM3 and HHFTM4 of Hacı Hasan Feyzi Mosque Tomb; It has been observed that it consists of metamorphic rock fragments, containing quartzite, marble and mica schist. It has been observed that the grain sizes are smaller than at the Prayer Place. Angular-grained quartz, round-grained marble and mica [biotite and muscovite], albite and few dolomite fragments were identified as minerals. Platy lime agglomerates were clearly identified as binders. As in the Prayer Place, it has been determined that they contain voids, although the interfaces between aggregate and binder were generally good [Fig. 12].
